**District 2 Fire Station
School Street
MEP Condition Report
&
Cost Estimate**

Town of Acton

South Acton, Massachusetts

September 30, 2004

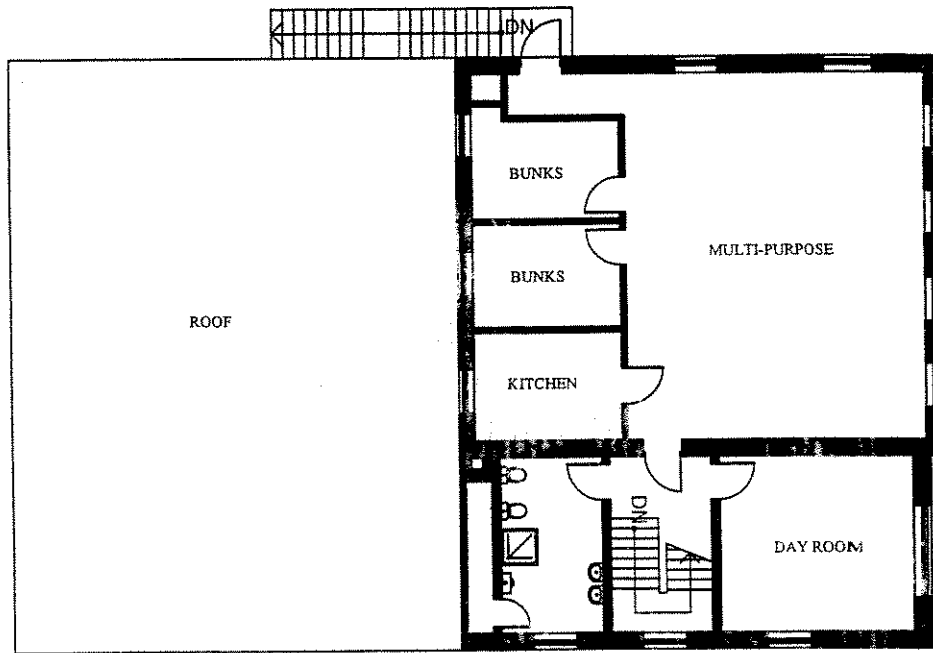
SECOND FLOOR

District #2 Fire Station - South Acton

Bath/shower room has two toilets, one shower, one sink, access is through the stairwell.

Bunk Rooms has beds and lockers.
